MTL TR 91-24

# EXAMINATION OF PROTECTIVE COATINGS UTILIZED ON ARMY DS2 CONTAINERS

VICTOR K. CHAMPAGNE, Jr., MARC S. PEPI,  
CATHERINE M. ZOLLER, and SAUL ISSEROW  
MATERIALS TESTING AND EVALUATION BRANCH

June 1991

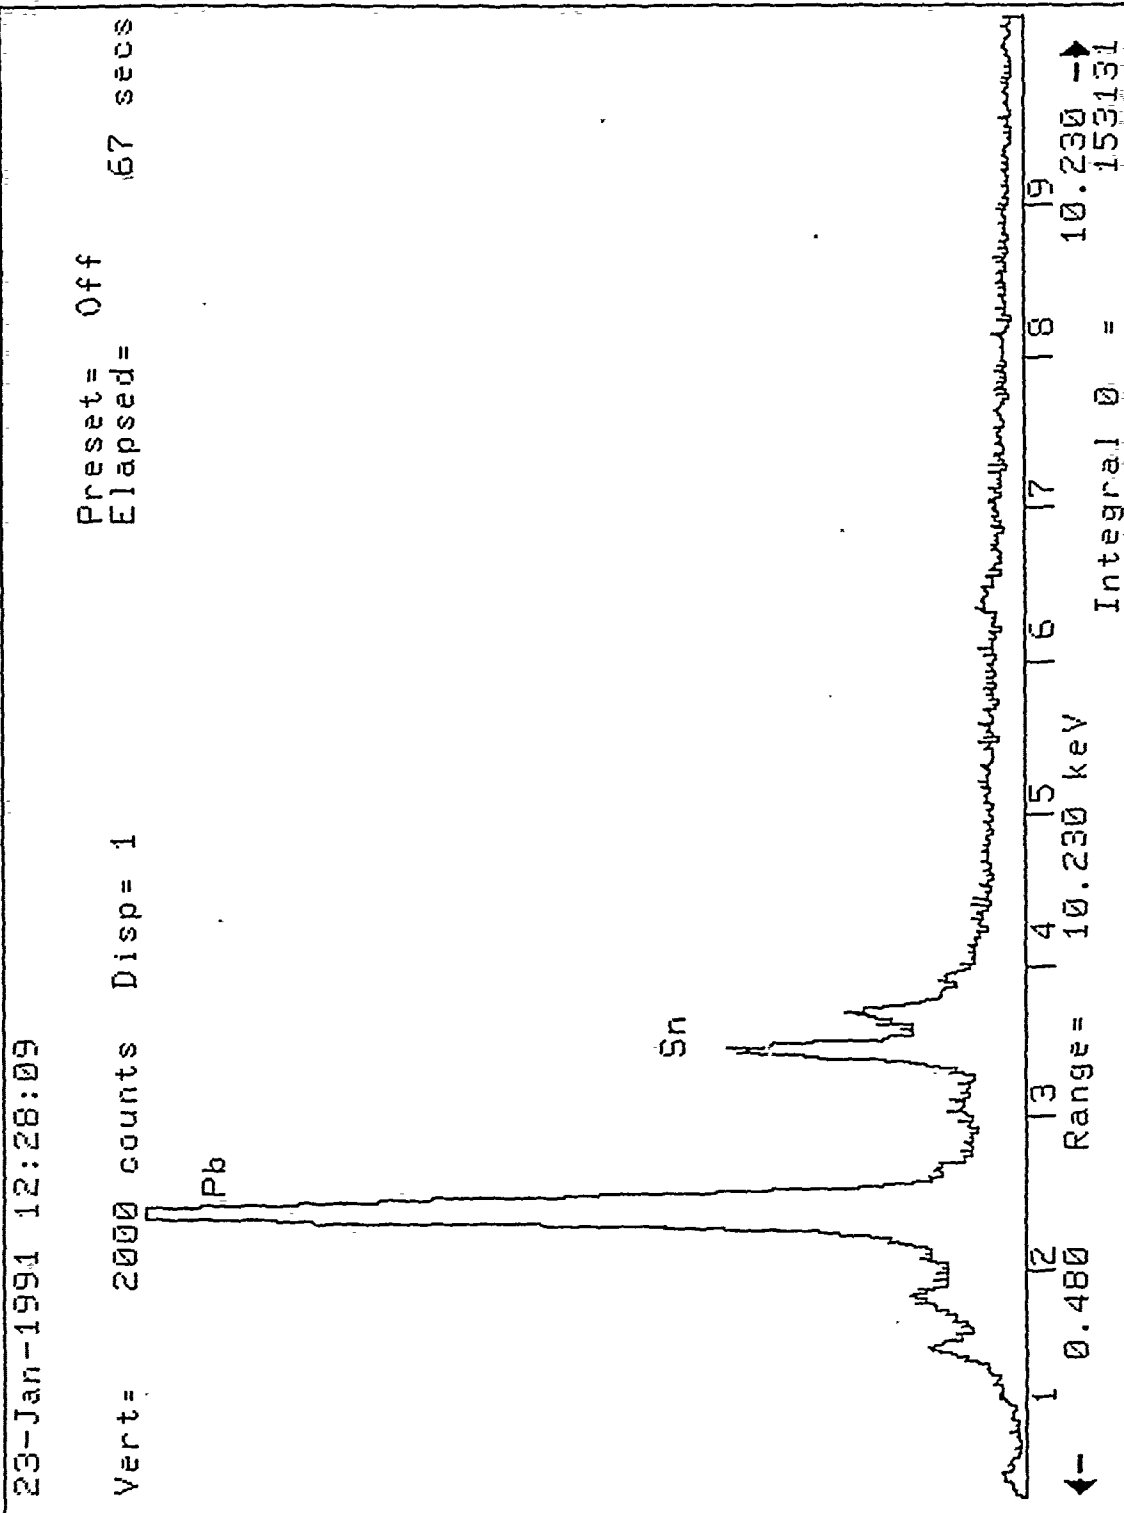
Figure 47. Energy dispersive spectroscopy of the interior of the 1-1/3-quart container.  
The main elemental constituents of lead and tin indicate aterne coating.

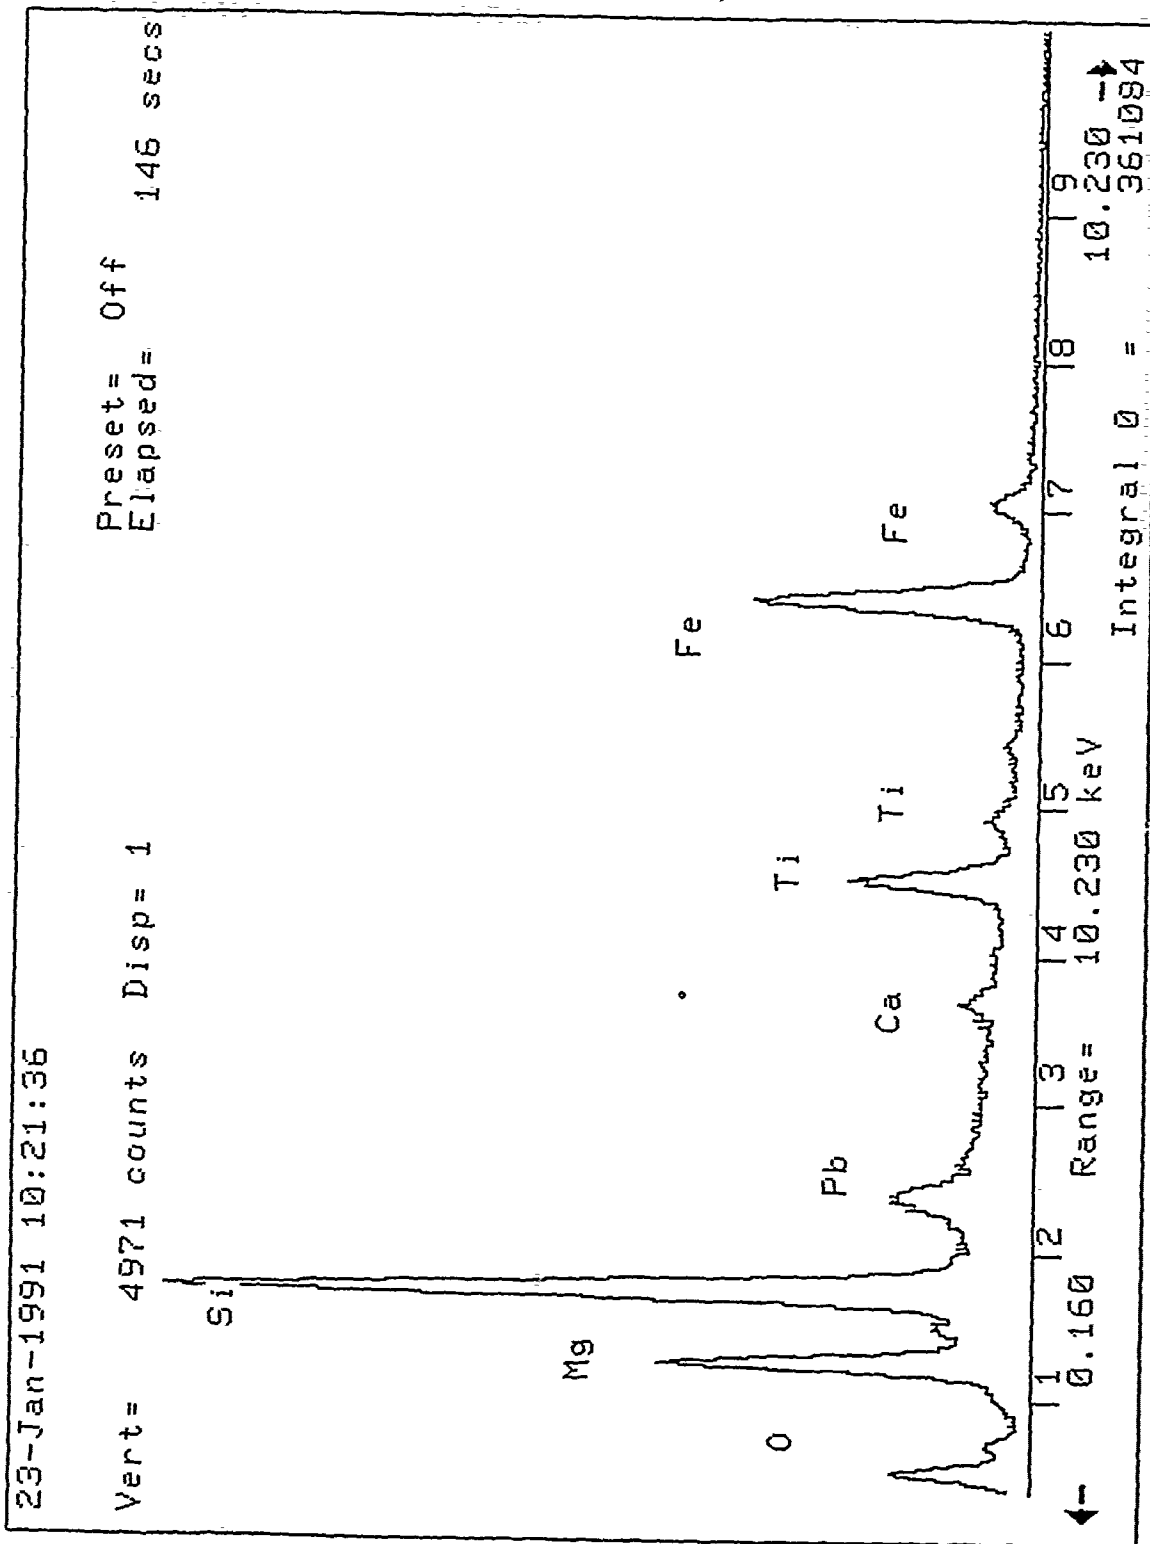
Figure 48. Energy dispersive spectroscopy of the alkyd coating present on the exterior of the 1-1/3-quart container. These elements are constituents of pigments added to the alkyd coating.

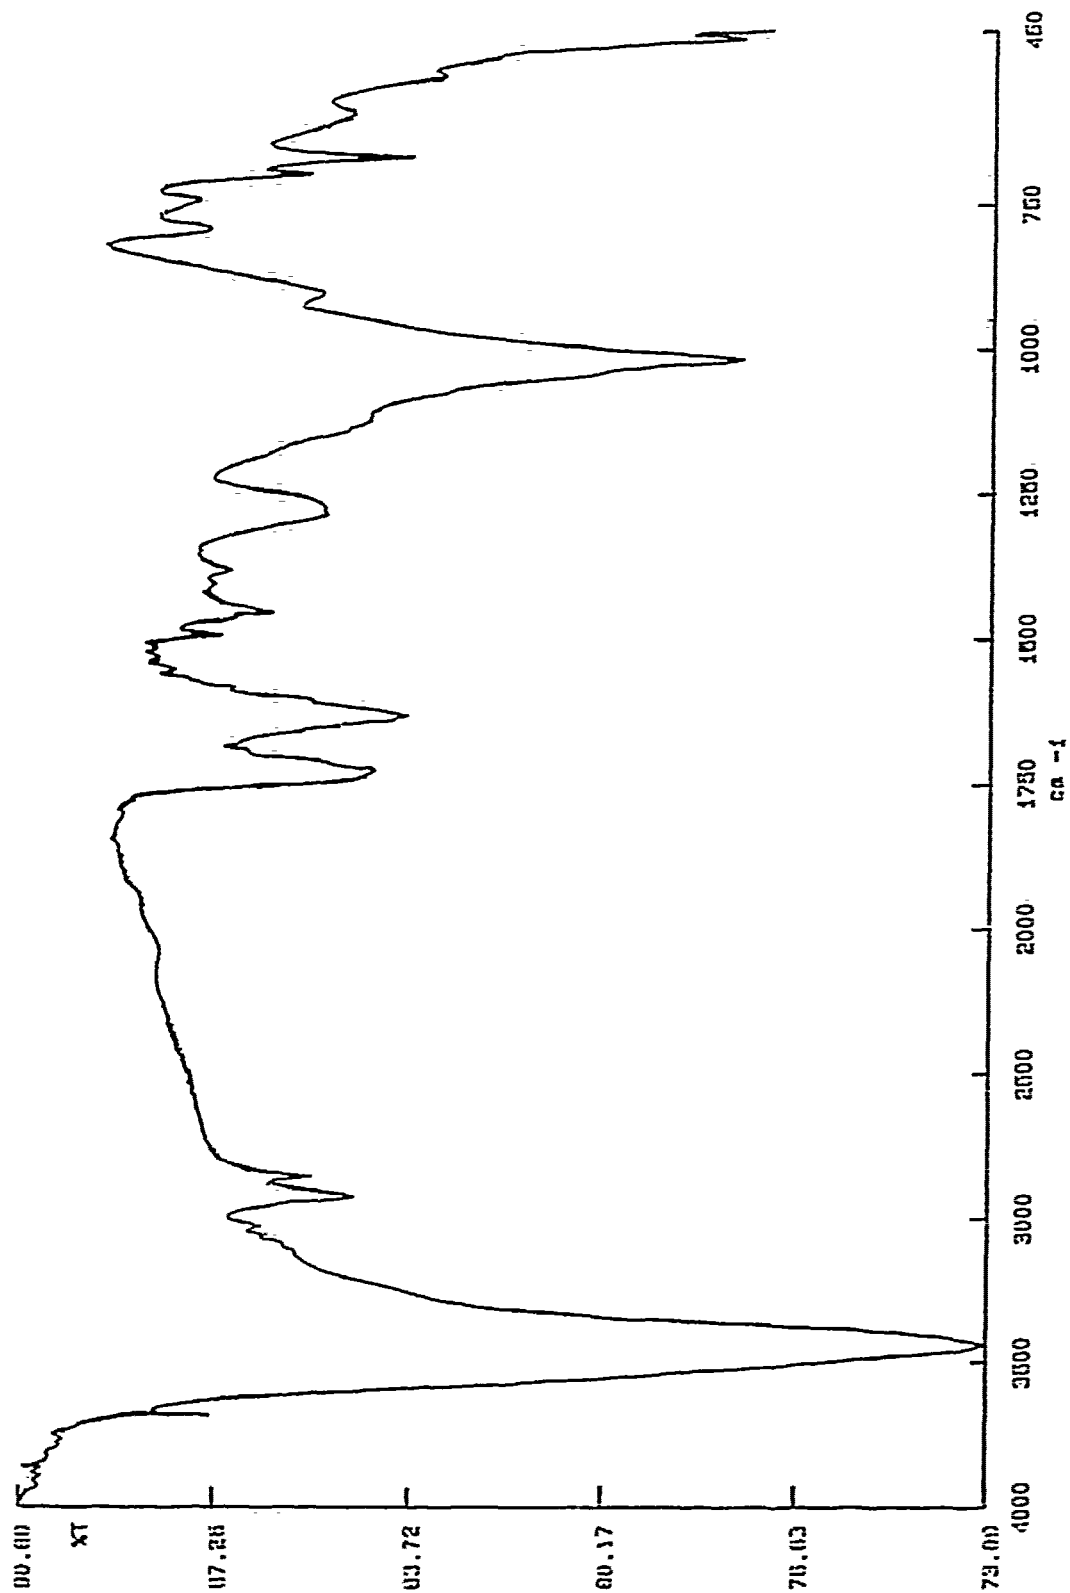
Figure 44 is an SEM micrograph of the exterior coatings located on the top weld of the 1-1/3-quart container. The black region separating the alkyd coating from the terne coating is an interface where there is no adhesion. The photograph identifies the terne coating and the alkyd topcoat. Figure 45 shows the interior terne coating observed on the top weld cross section. Both interior and exterior terne coatings were uniform and displayed good adhesion to the steel substrate. Figures 46 and 47 reveal the resulting spectrum obtained from the exterior and interior terne coating, respectively. The only major peaks detected consisted of lead and tin which are the primary elemental constituents of the coating. Figure 48 is the resulting spectrum of the alkyd coating present on the 1-1/3-quart container. Figure 49 represents the infrared spectrum of the same coating which indicates that the coating was an alkyd.

Figure 49. Infrared spectra collected from topcoat of 1-1/3-quart container indicative of an alkyd coating.
